Vegetation - Main Road

Archeological - Main Road

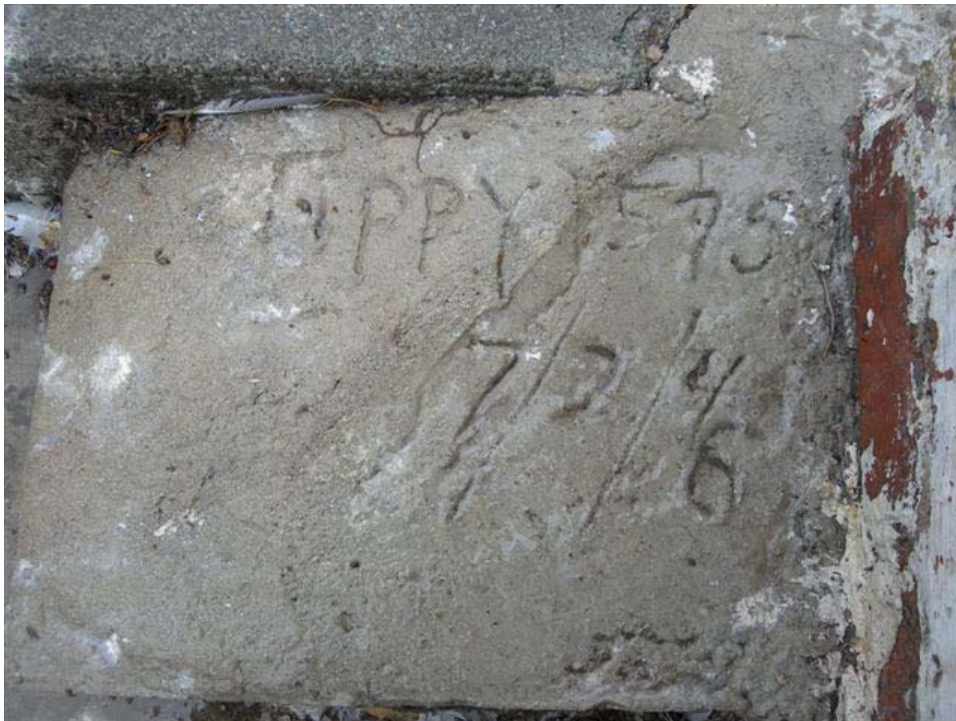
Figure 3 - 194a. Inscription in Officers' Row Terrace - "Tippy 575 7/2/46," behind Officers' Row 9 foundation wall. (Photo Courtesy of Shelagh Fritz (Officers' Row graffiti 1.jpg))

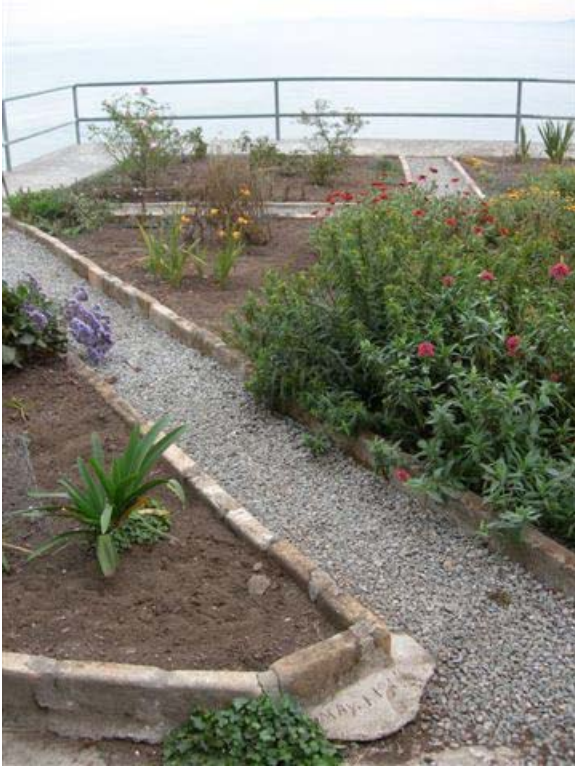
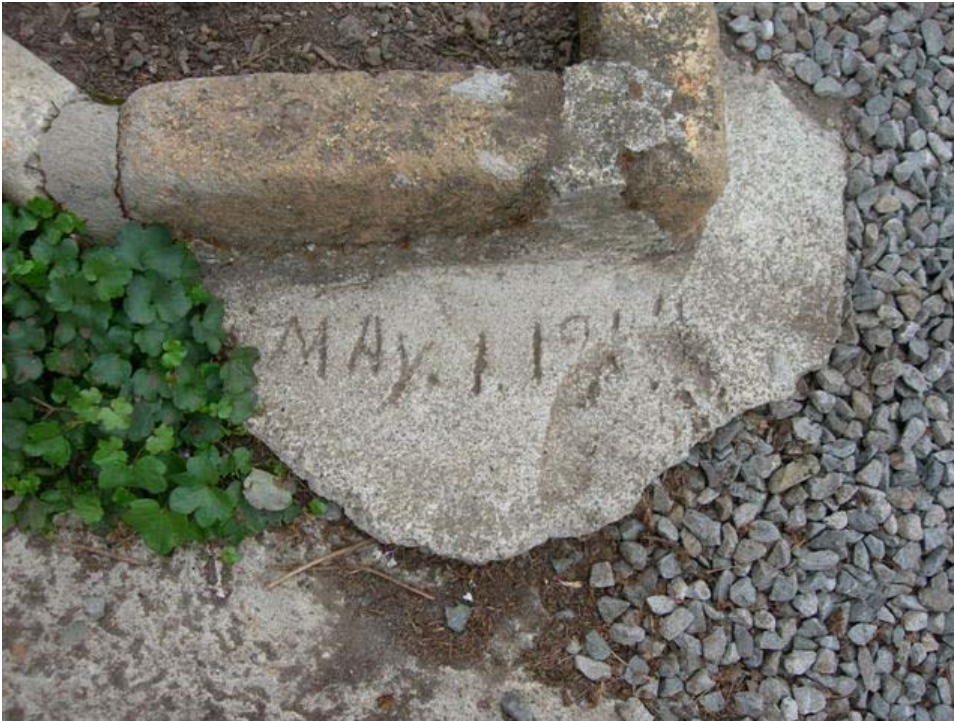
Figure 3 - 194b. Inscription in Officers' Row Terrace - "May 1, 19XX," located within Officers' Quarters 8 Garden (Photos Courtesy of Shelagh Fritz (Officers' Row graffiti 2.jpg, Officers' Row graffiti 3.jpg))

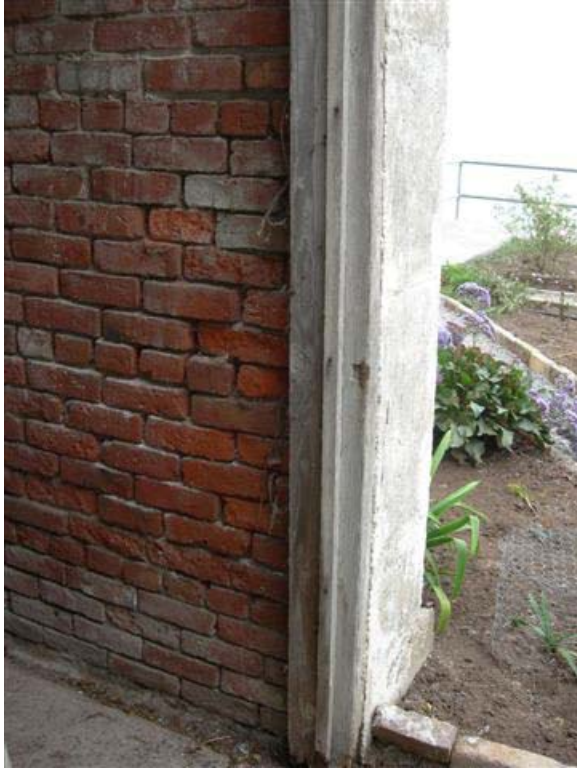
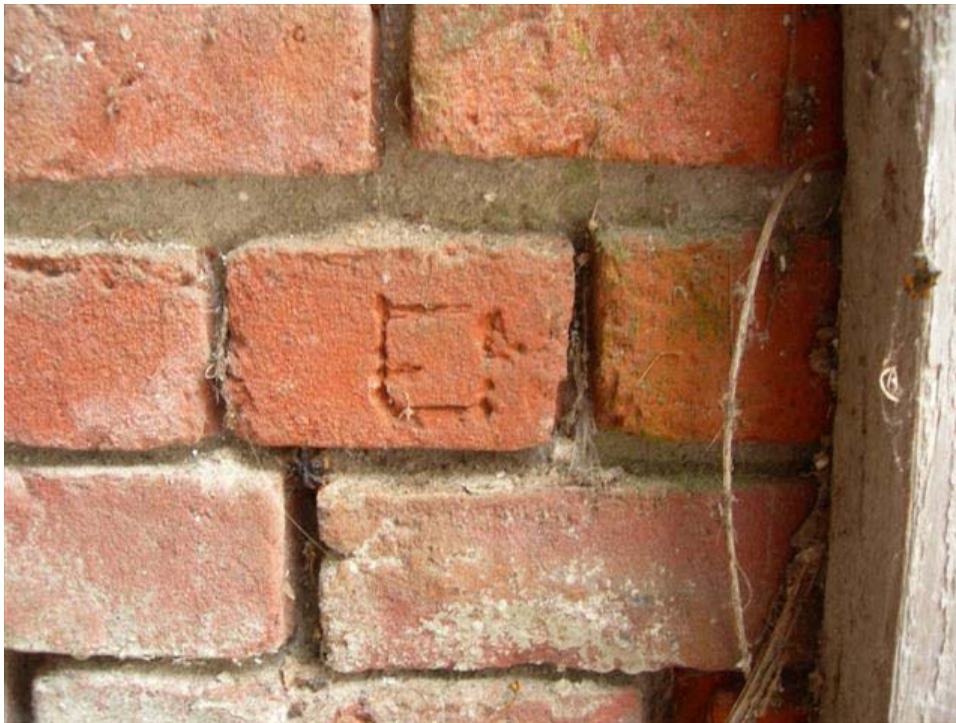
Figure 3 - 194c. Inscription in Officers' Row Terrace - "EM," located within remnant coal bin/garden storage structure in Officers' Quarters 8 Garden. (Photos Courtesy of Shelagh Fritz (Officers' Row graffiti 4.jpg, Officers' Row graffiti 5.jpg))

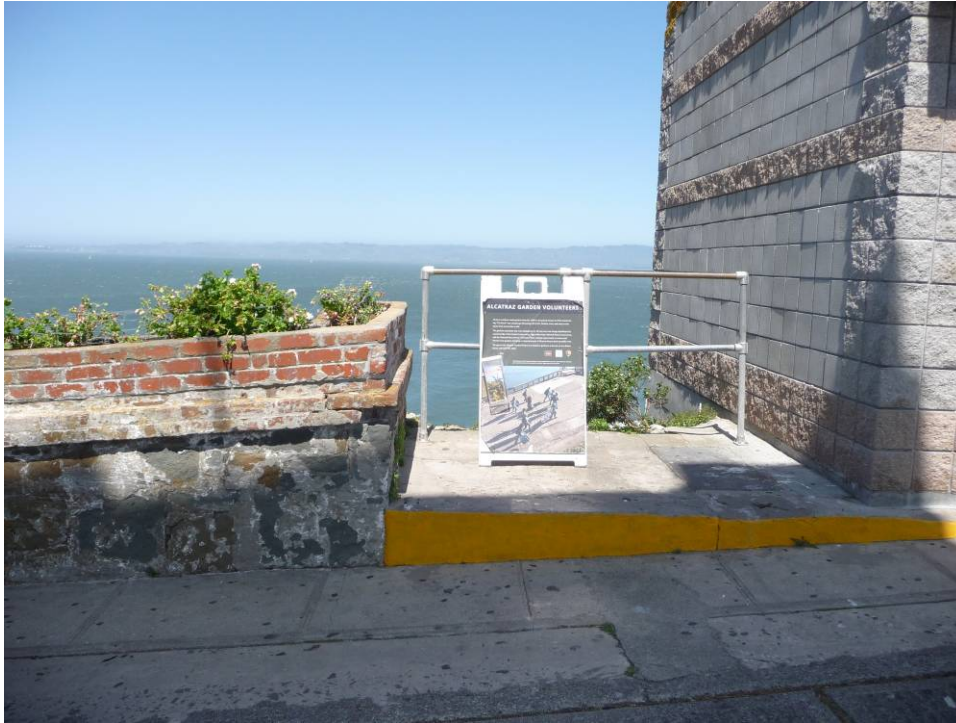
Figure 3 - 195. Pipe Railing (SR34) north of Restroom on Main Road (MBD P1000430.JPG)

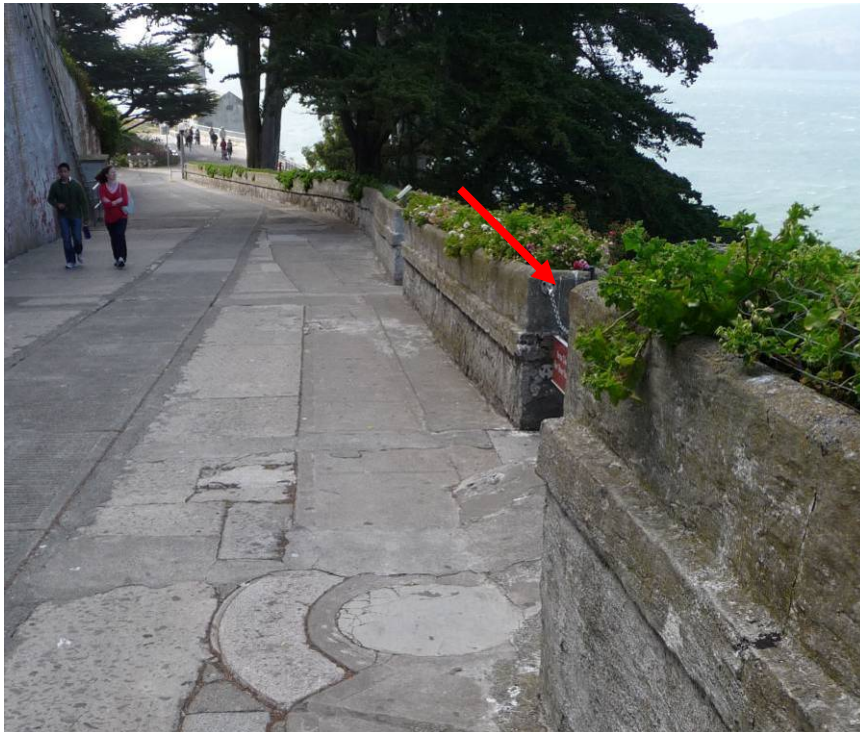
Figure 3 - 196. Chain Railing (SR32) on Main Road between Switchback Three and Lighthouse. Note the circular outline of the coal delivery opening from the previous Officers Quarters in the road paving. (MBD SR32.JPG)

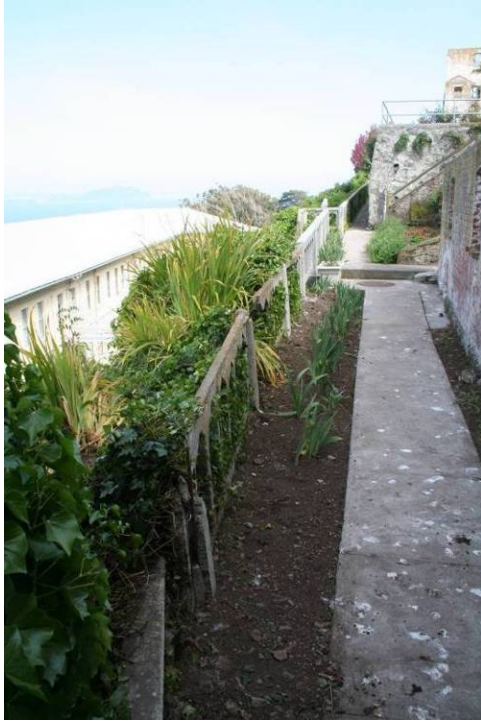
Figure 3 - 197. Security Railing (SR24) along east side of Officers' Row near Officers' Quarters 9, extends along north edge of Officers' Row, see photograph below (MBD IMG_2843.JPG)

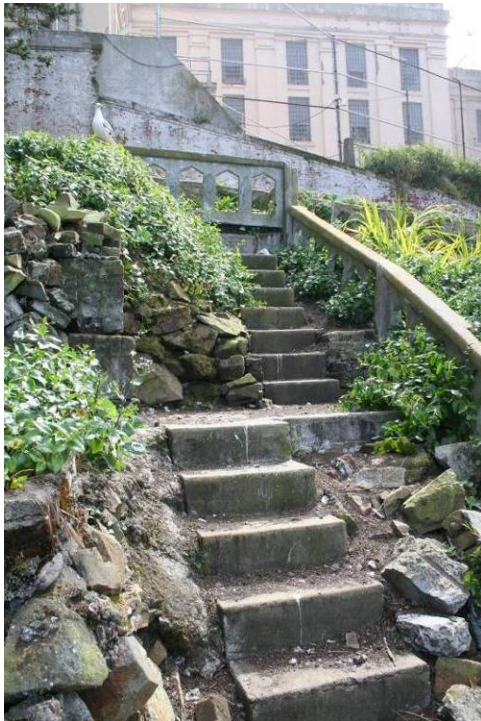
Figure 3 - 198. 9a Stairs with SR24 security railing at far north end of Officers' Row (MBD IMG_2846.JPG)

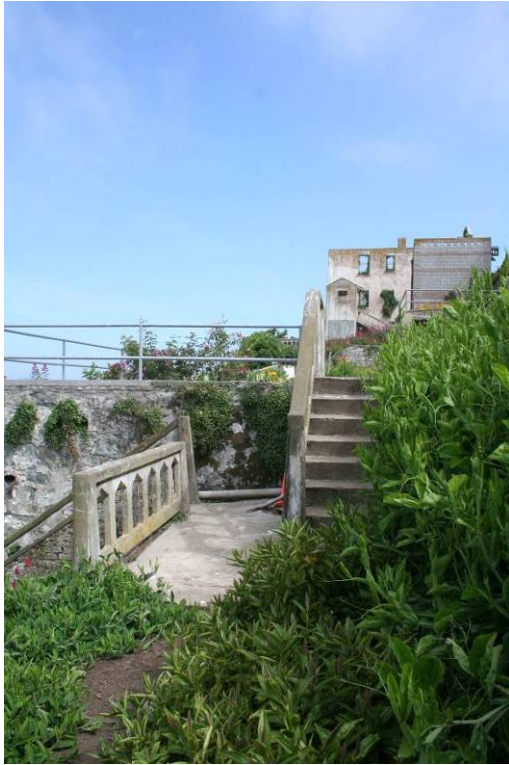
Figure 3 - 201. Staircase between 8a gardens and Officers' Quarters 8 in Officers' Row with pipe railing (SR11) and decorative concrete railing (SR24) (MBD IMG_2856.JPG)

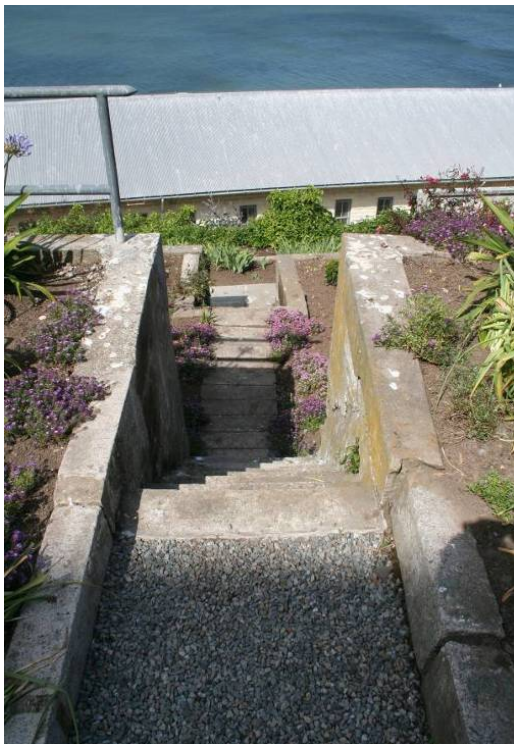
Figure 3 - 202. Stairs in Garden Terrace 7a in Officers' Row with pipe railing (SR11) on left (MBD IMG_2873.JPG)

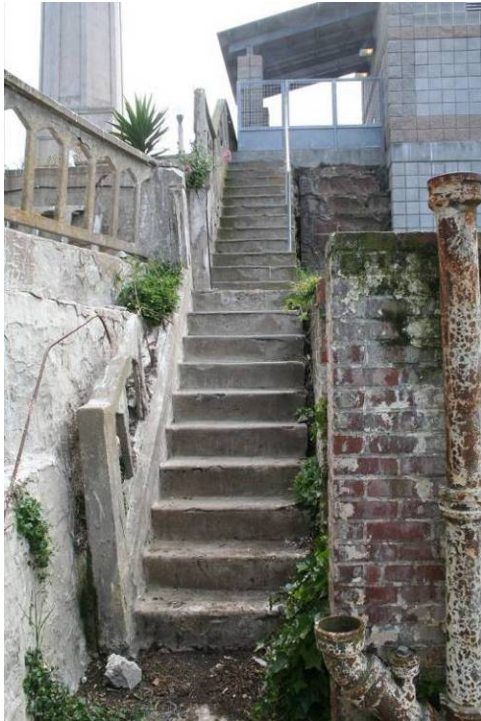
Figure 3 - 203. Staircase between Officers' Quarters 7 and Warden's House garden in Officers' Row with pipe railing (SR12) and decorative concrete railing (SR35) (MBD IMG_2879.JPG)

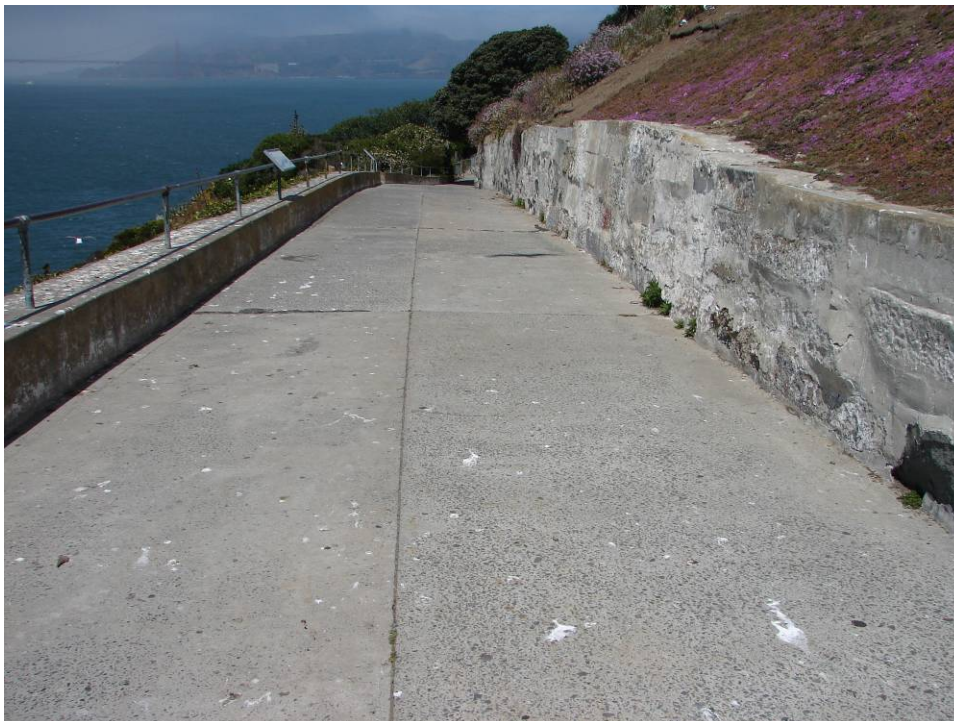
Figure 3 - 204. Upper West Road looking north from near Lighthouse. Cellhouse Slope Garden is on right and concrete seatwall with pipe railing (SR36) in left of photo. Masonry block wall is on right (see structures). (MBD DCS03071.JPG)

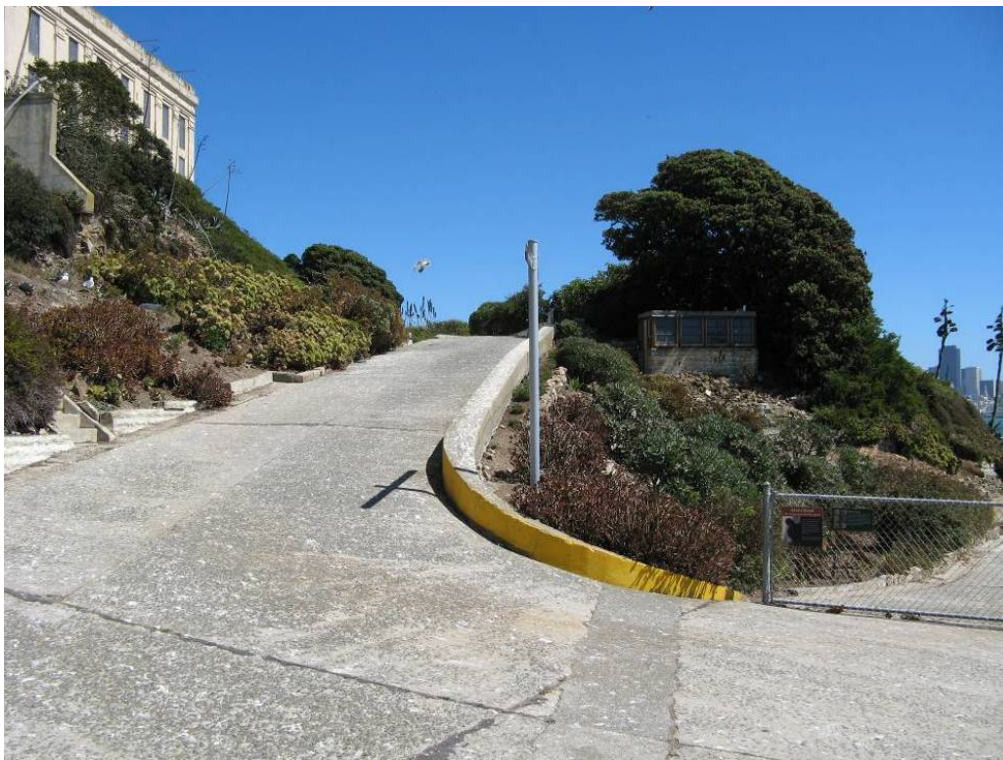
Figure 3 - 206. Concrete Curb, Upper West Road, Road to Parade Ground on right, Toolshed in center between the two roads and Main Prison on the left (MBD IMG_4115.JPG)

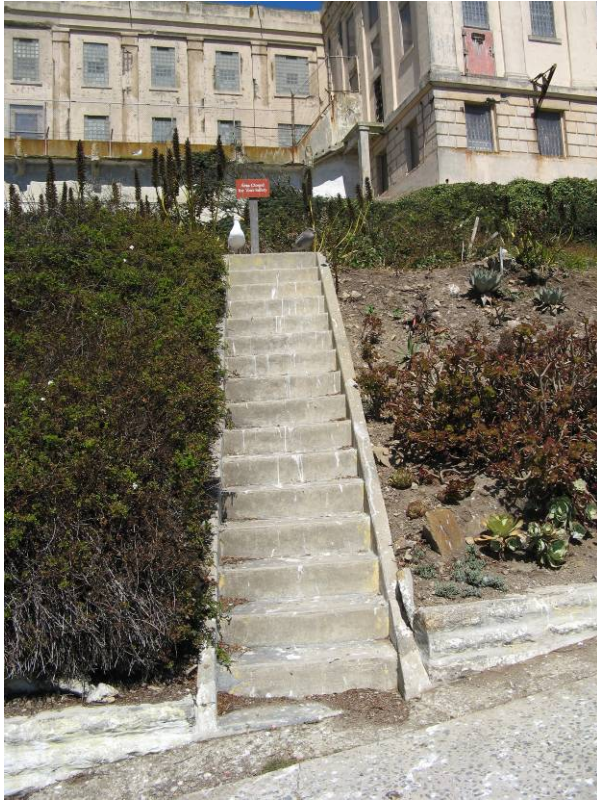
Figure 3 - 207. Staircase to West Lawn, south of Stockade/Recreation Yard and accessed from Upper West Road, Main Prison is in the background (MBD IMG_4121.JPG)

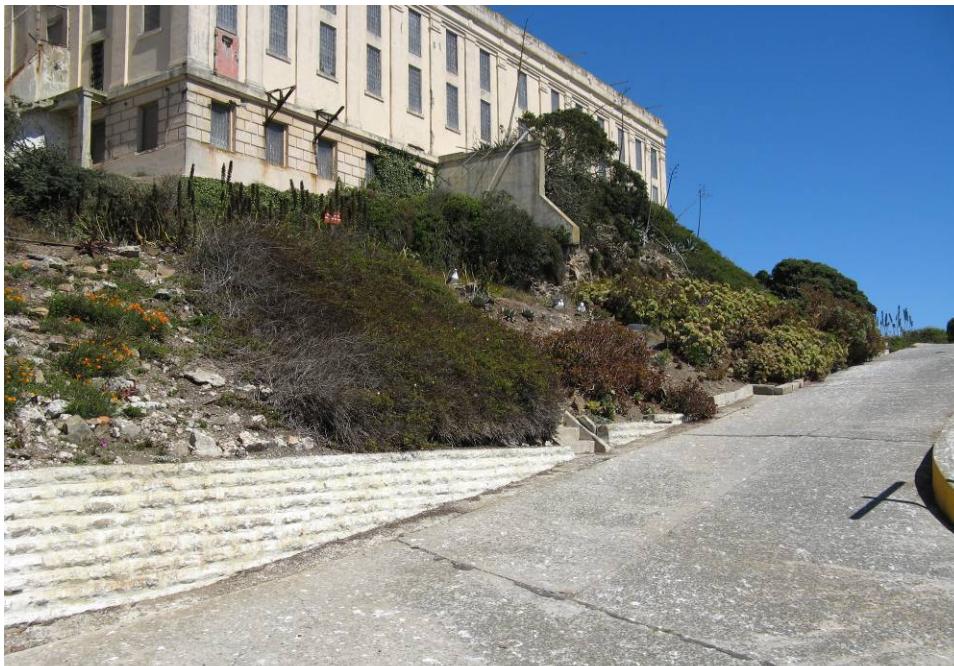
Figure 3 - 208. Stone Wall at base of West Road Terrace; Main Prison in the background(MBD IMG_4114.JPG)

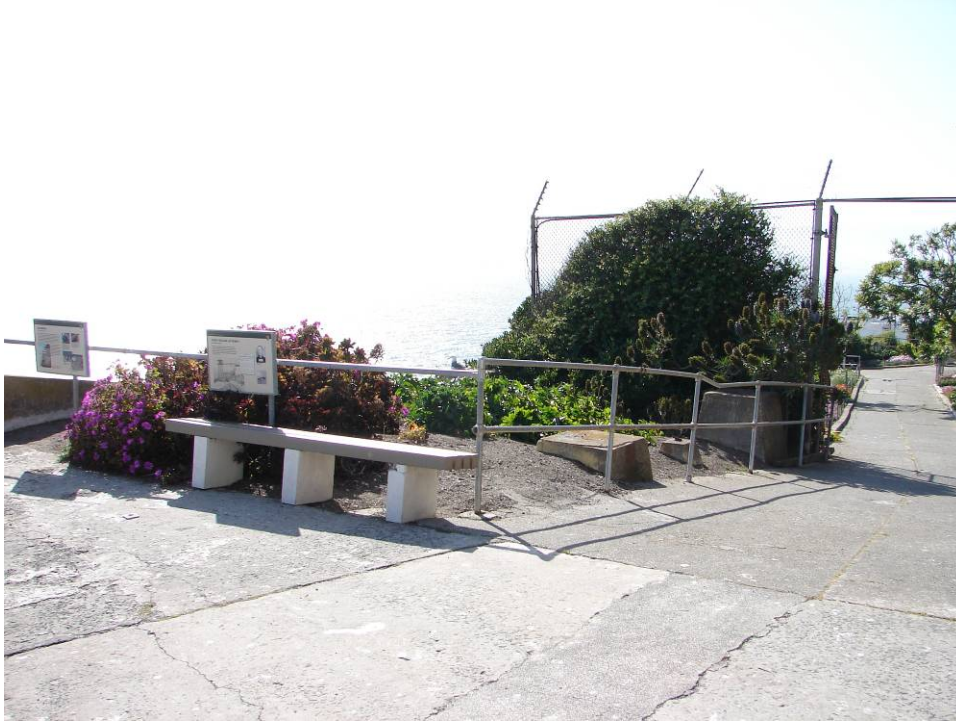
Figure 3 - 211. Remnants of Road Tower foundation behind metal pipe railing, prison era fence in background. (SR62) (MBD DSC02886.JPG)

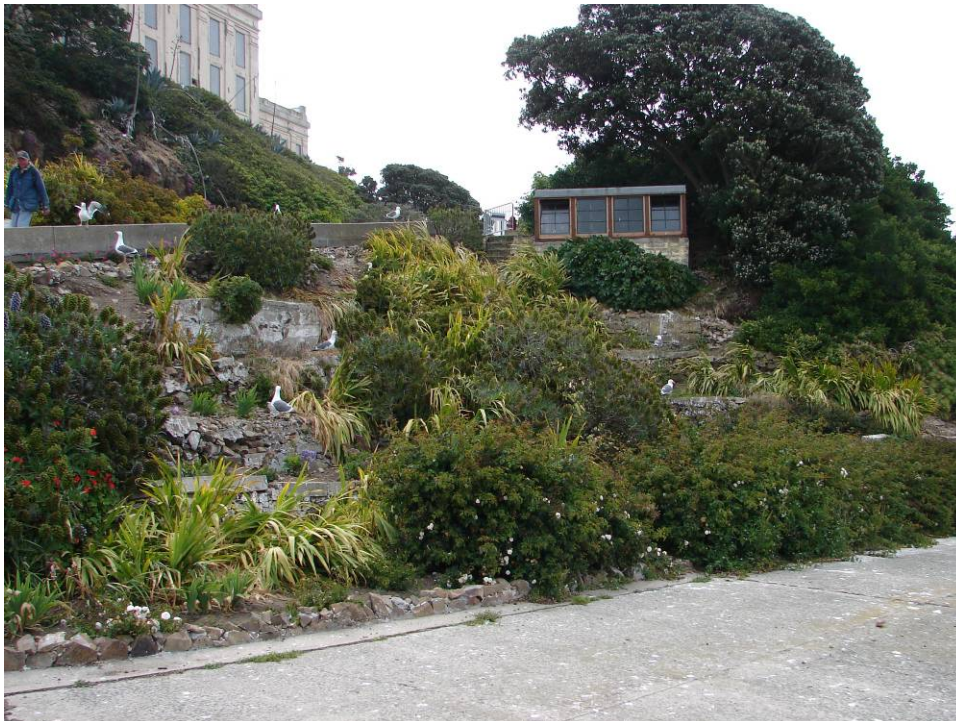
Figure 3 - 212. Rubble Curb, Toolshed Terraces, Reconstructed Toolshed (MBD DSC03265.JPG)

<i>Feature (Type)</i>	<i>Bldg #</i>	<i>Figure #</i>	<i>Description</i>	<i>Condition</i>
Toolshed Terraces		3-225	Terraced garden north of the Toolshed. Species include <i>Echium candicans</i> , <i>Chasmanthe</i> , <i>Pelargonium sp.</i> , Spuria iris, <i>Rosa 'Felicite et Perpetue'</i> .	Fair
Rose Garden		3-227	New planting beds and gravel paths. On site of former 1882 Hospital	Good
Water Tank Terrace		3-228	Vegetation on terrace south of Water Tower. Species include: <i>Cordyline australis</i> , <i>Aeonium sp.</i> , and <i>Chasmanthe floribunda</i>	Poor
Main Road East Slope		3-131 3-133 3-137	Vegetated slope north of Switchback 2. Species include: Monterey Cypress, <i>Eucalyptus</i> , and <i>Prunus sp.</i> , as well as <i>Albizia distachya</i> , <i>Hedera Helix</i> , and <i>Centrathus ruber</i>	Fair

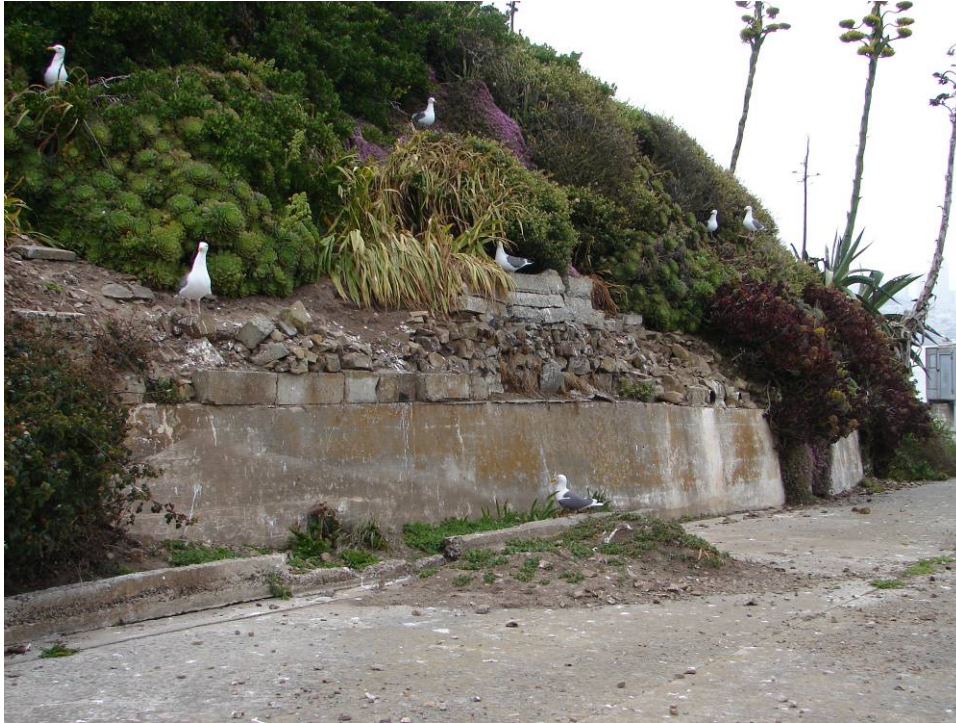
Figure 3 - 213. Concrete/Rubble Wall on east side of Road to Parade Ground, observation blind in far right of photo (MBD DSC03273.JPG)

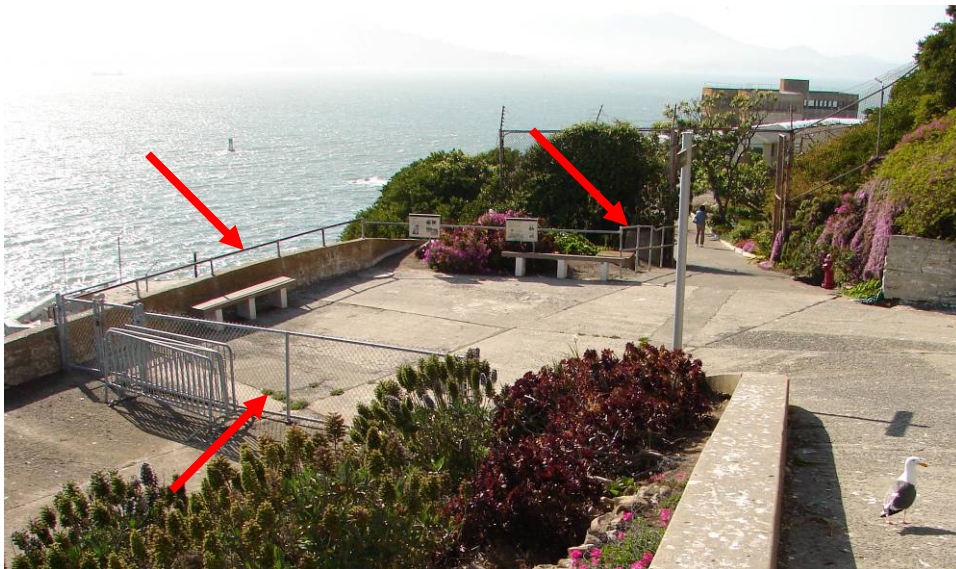
Figure 3 - 214. Chain link safety railing (SR64), pipe railing (SR63) on concrete wall in left of photo, and metal pipe railing (SR62) in center of photo (MBD UWR_RPG_SB.JPG)

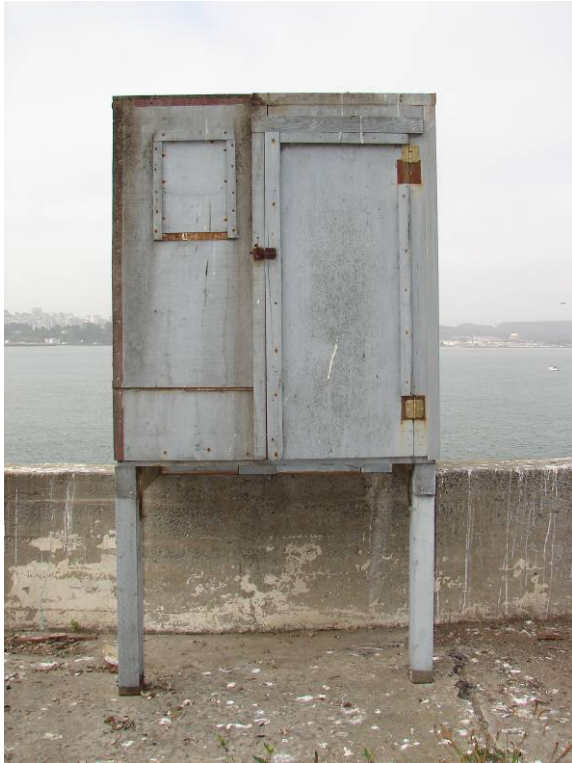
Figure 3 - 215. Observation blind on west side of Road to Parade Ground (MBD DSC03278.JPG)

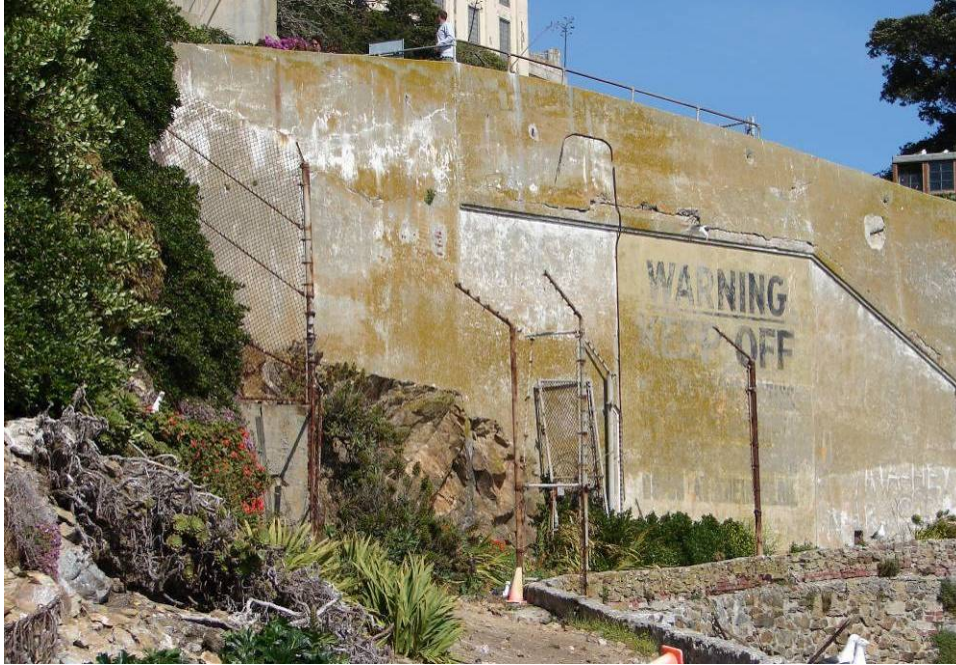
Figure 3 - 217. “Warning Keep Off” sign on Masonry Retaining Wall below former site of Road Tower, viewed from Incinerator area (MBD DSC02853.JPG)

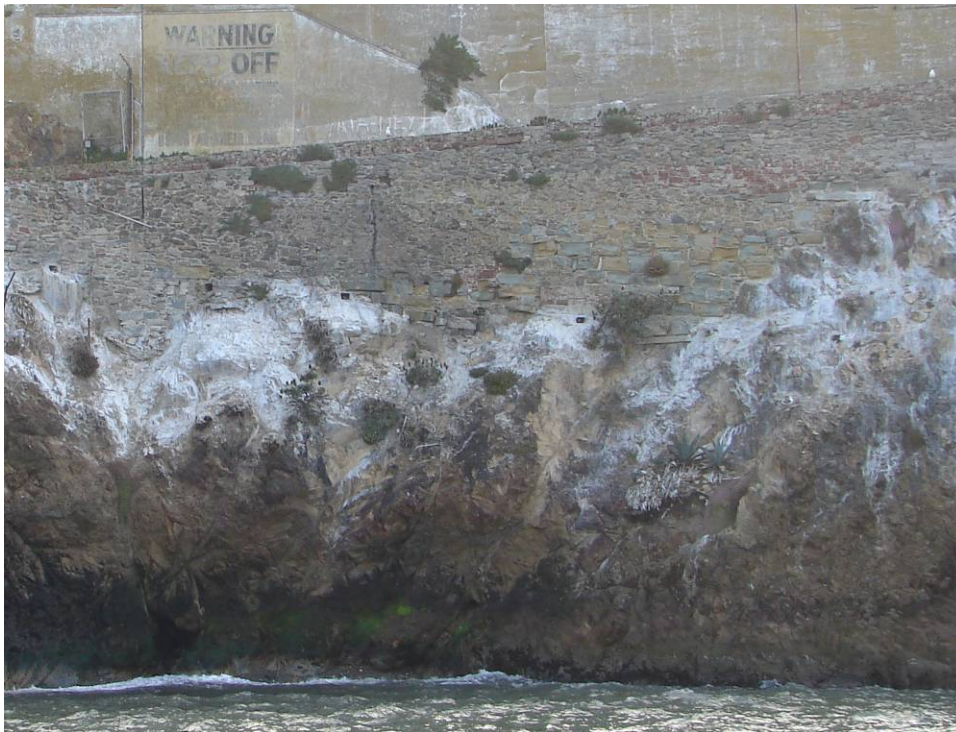
Figure 3 - 218. Recesses in Rock (remnant supports for Perimeter Sentry Walk), Lower West Road retaining wall, “Warning Keep Off” sign on concrete retaining wall below Road Tower site (MBD Catwalk.JPG)

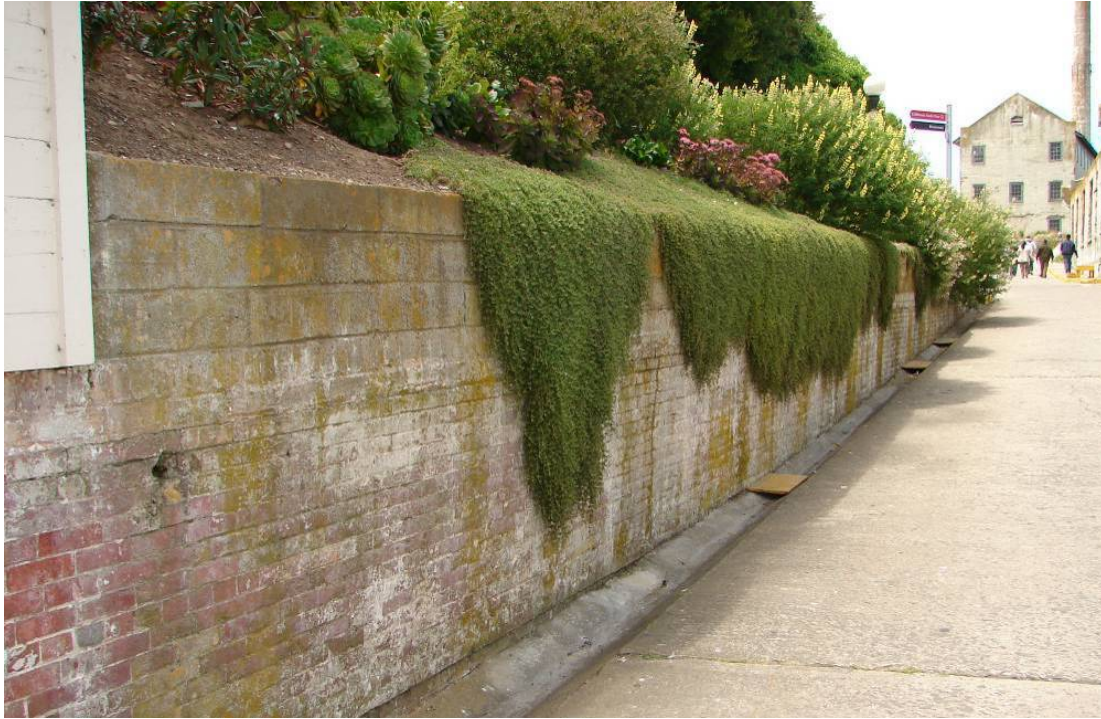
<i>Feature (Type)</i>	<i>Bldg #</i>	<i>Figure #</i>	<i>Description</i>	<i>Condition</i>
Sallyport Garden with SR6 and SR8	22	3-219	Exhibits a diversity of ornamental plants as it did historically.	Good
Electric Shop Bed	89	3-220	Exhibits a diversity of ornamental plants as it did historically.	Good
Officers' Row	The terrace walls, basement walls, paths, stairs, and railings have been cleared of ivy and weeds. Brick and concrete edging still lines the paths and planting beds and stepping stones are still in place. (Officers' Row Gardens Treatment Plan) (Figure 3-116). See Table 14 Buildings – Main Road for individual images			
Officers' Quarters 7	7	3-117	Building foundation nearest to Warden's House. Restroom has been constructed on a portion of the site. Light groundcover exists.	Fair
Garden Terrace - 7a	7a	3-118	Four foot tall block wall planting beds just north of Officers' Quarters 7. Common plants include: <i>Narcissus sp.</i> , <i>Rosa sp.</i> , boxwoods, <i>Spirea sp.</i> , <i>Fuchsia sp.</i> , and heliotrope. ¹²	Good

Figure 3 - 220. Electric Shop Bed, retaining wall, and trench along west side of Main Road (MBD DSC02509.JPG)

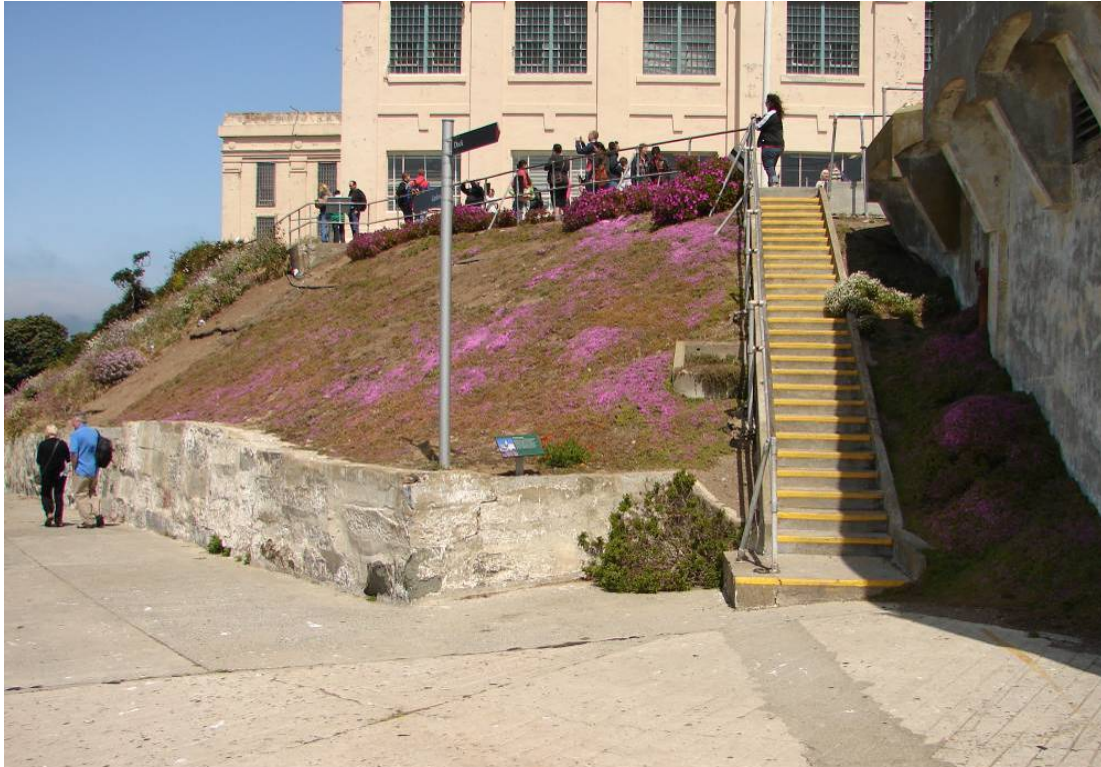
Trough Wall		3-226	Ivy Leaf Pelargoniums planted in Trough Wall from SB3 to Lighthouse on Main Road	Good
Cellhouse Slope	68	3-222	Vegetated Slope below Main Prison Plaza. Planted with <i>Diosanthemum floribundum</i> , <i>Pelargonium</i> 'Prince Bismarck' and <i>Rosa</i> 'Felicite et Perpetue'	Fair
West Lawn	68	3-223	North - semi-overgrown lawn west of Main Prison (includes <i>Chasmanthe floribunda</i>). Perennial Lawn borders have been rehabilitated. South- completely hidden by tall overgrowth (<i>Ficus carica</i> , and <i>Albizia</i>).	North: Fair South: Poor
West Road Terraces		3-224	Terraced garden located south of Recreation Yard/Stockade. Exhibits a diversity of ornamental plants as it did historically.	Fair

Figure 3 - 222. Cellhouse Slope (MBD DSC03067.JPG)

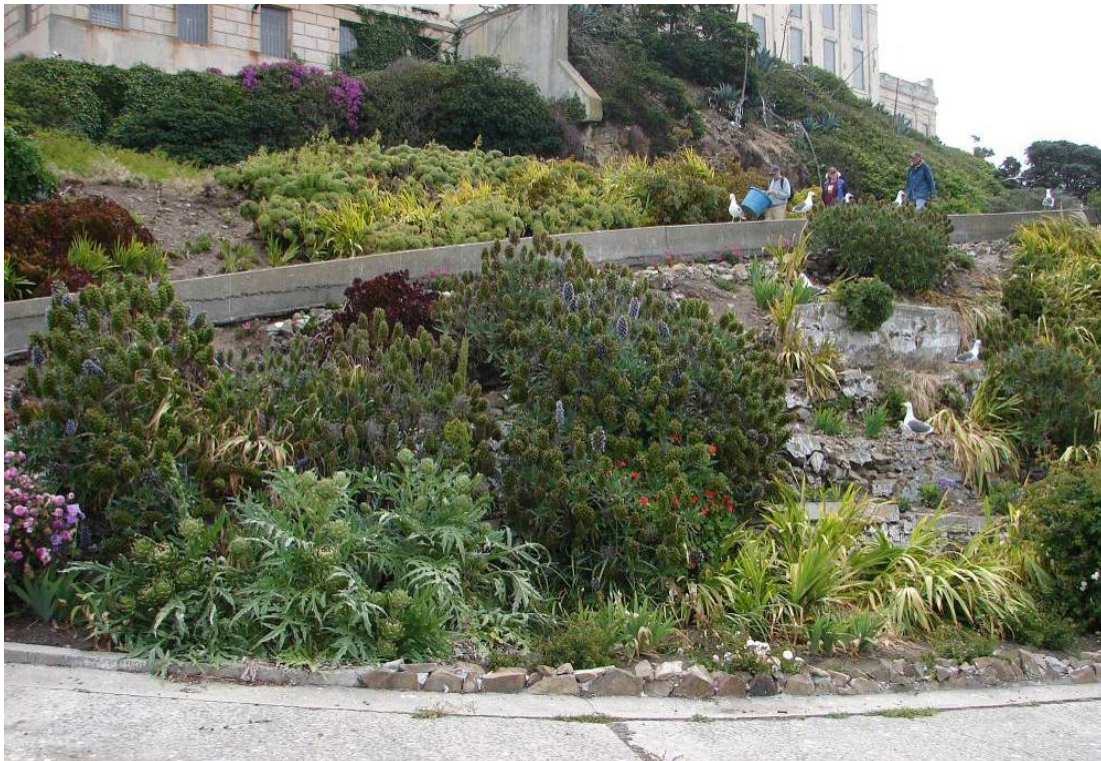
Figure 3 - 225. Toolshed Terraces (MBD DSC03264.JPG)

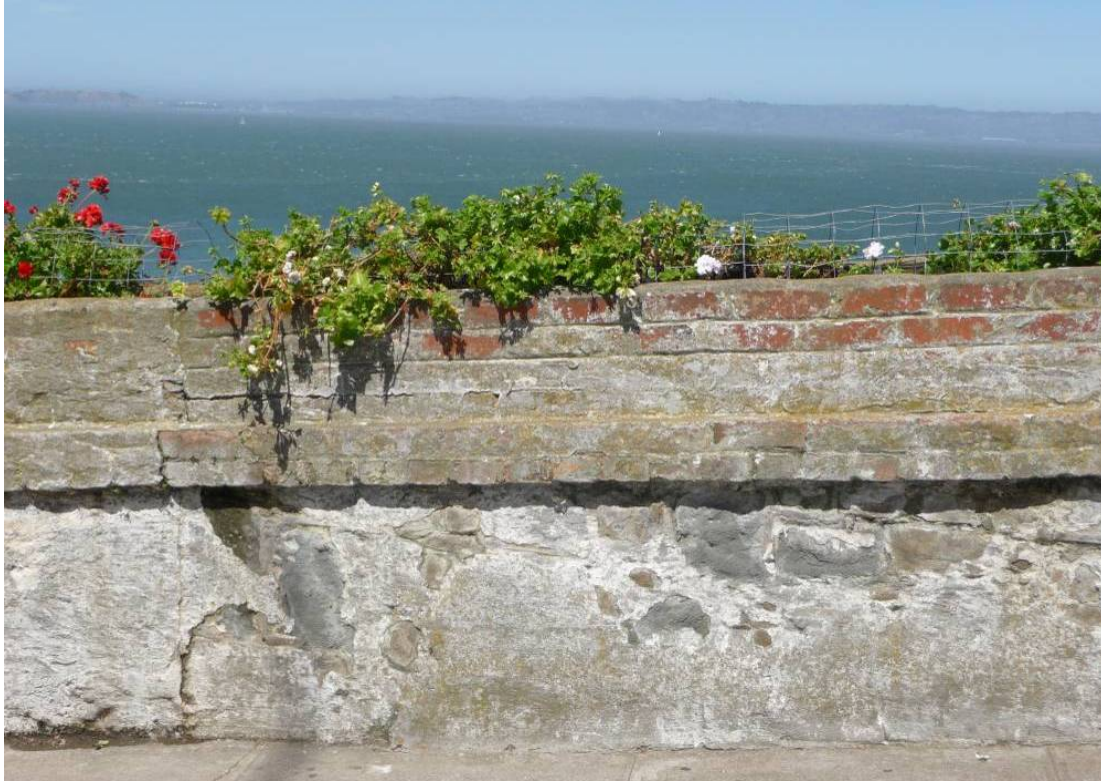
Figure 3 - 226. Trough Wall (MBD P1000424.JPG)

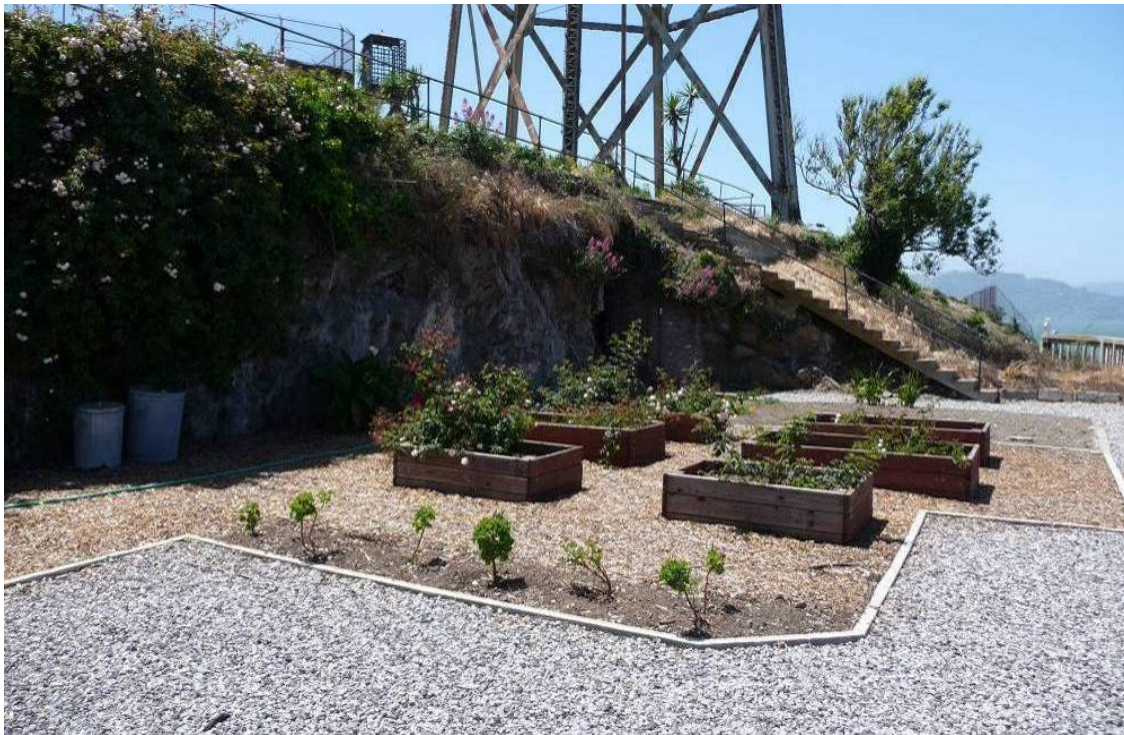
Figure 3 - 227. Rose Garden (MBD P1000783.JPG)
